IMPACTS ON THE HUBBLE SPACE TELESCOPE WIDE FIELD AND PLANETARY CAMERA 2: MICROANALYSIS AND RECOGNITION OF MICROMETEOROID COMPOSITIONS.

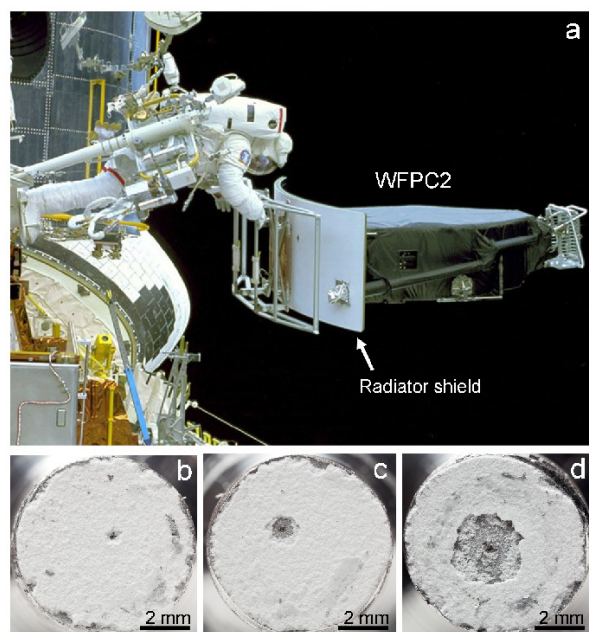
Introduction: Postflight surveys of the Wide Field and Planetary Camera 2 (WFPC2) on the Hubble Space Telescope have located hundreds of features on the 2.2 by 0.8 m curved plate (Fig. 1), evidence of hypervelocity impact by small particles during 16 years of exposure to space in low Earth orbit (LEO) [1,2].

Fig. 1. a) WFPC2 is removed from the Hubble Space Telescope during service mission 2 (STS-125) in 2009; b-d) diverse sizes of impact structure on WFPC2 cores.

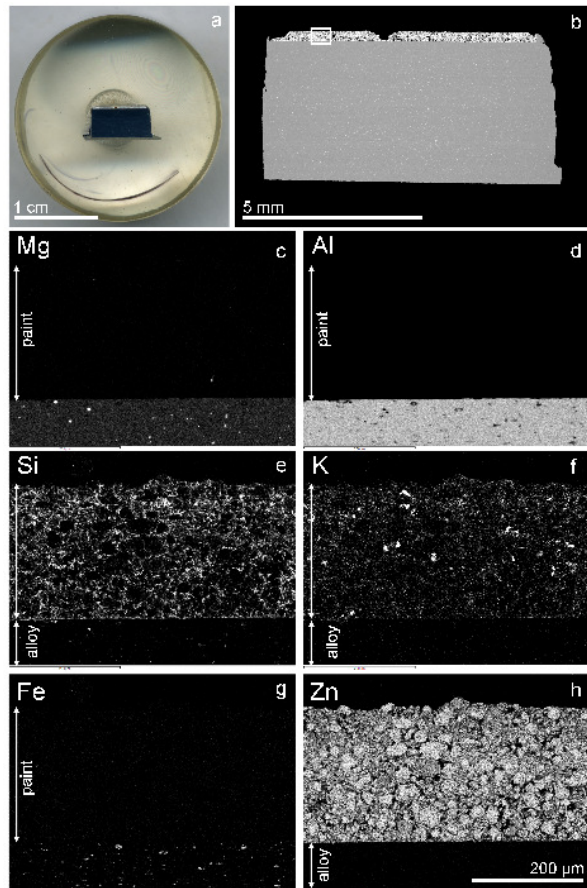
Results: The vertical section (Fig. 2) showed that the paint is a mixture of porous zinc titanate grains (2 types), bound with potassium silicate, and containing reactive K salts. The alloy bulk composition is: ~ 97 wt % Al; 0.86 % Mg; 0.76 % Si; 0.25 % Cr; 0.13 % Mn; 0.58% Fe and 0.39% Cu; trace P, Ti, V, Ni, Ga and Rh. Alloy inclusions of μm scale are rich in Mg + Si (~ 0.3 alloy volume), and Fe+Cr+Mn (~ 1.8 % volume).

Fig. 2. Vertical cross section: a) optical image; b) BEI; and c) to h) EDX maps showing paint and alloy layers.

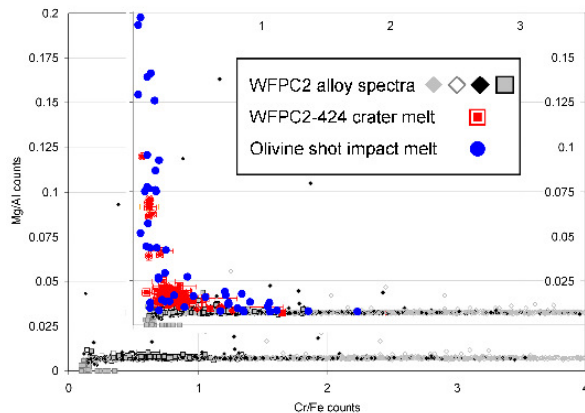
1300 spectra taken from points on polished metal, and from areas on exhumed alloy seen on other cores, gave a very tight clustering of Mg/Al values (Fig. 3).

Fig. 3. Mg/Al vs Cr/Fe X-ray counts for: alloy (grey and black); and (inset) melt from experimental olivine impact (blue); and melt in WFPC2 sample 424 (red).

Analyses of metal-rich melts created by laboratory impact of olivine [5] fall well outside the plot position of the alloy (Fig. 3), as do the captured silicate grain (olivine?) and alloy melt in sample WFPC2-424 [2,4].

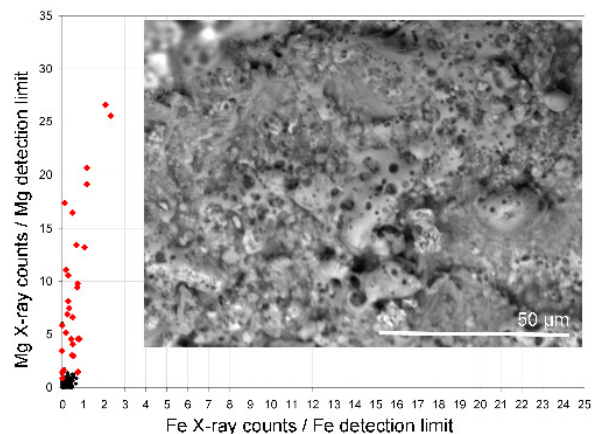
To calibrate a second plot type, for frothy paint melt, 200 spectra were taken from a clean paint surface (and areas on the polished vertical section) giving a tight cluster (Fig. 4). Fe was not found above detection limit, and Mg in only a few spectra (all $> 2 \times$ detection limit, ~ 0.1 wt %). ZOT paint is therefore a good medium for recognition of the most abundant (i.e. Mg- and Fe-rich) MM materials. The higher the proportion of impactor material in the melt, the further the analysis population deviates from the substrate, as seen in crater 124 (Fig. 4). However, if alloy was also melted, caution is required, as Mg- and Fe-rich inclusions may be included, and the Mg/Al vs Cr/Fe plot is more useful.

Fig. 4. Plot of Mg vs Fe X-ray counts above detection limits on: clean WFPC2 paint (black); frothy paint-rich melt from a small WFPC2 impact, sample 124 (red).
